Inspection Details:	Comprehensive Home Owners Inspection Plaster Cladding Weather-tightness Assessment Non-invasive Moisture Testing Infrared Thermal Imaging
Reference:	Sample Report Low Risk Monolithic Plaster Cladding
Inspection Address:	Undisclosed Sample Report Auckland
Date:	Tuesday, December 6, 2016
Client:	Undisclosed
Client Phone Number:	Undisclosed
Time of Inspection:	Undisclosed
Weather:	12:00pm
House Status:	Occupied
Report is prepared for the client only and not transferable	
SPPI PO Box 80-274 Green Bay Auckland 0643	Inspector: Mark Drew NZS 4306 Compliant Building Inspectors Member of Master Builders Association ISO Qualified Thermographer

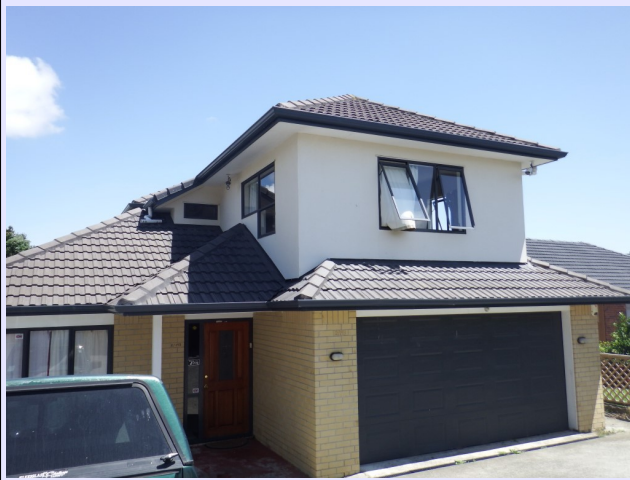
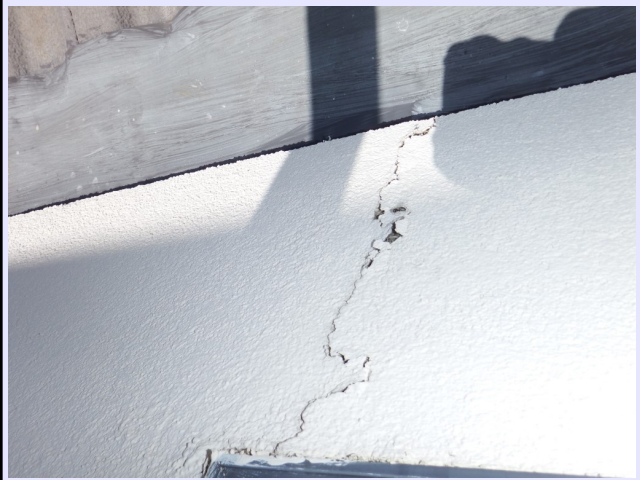
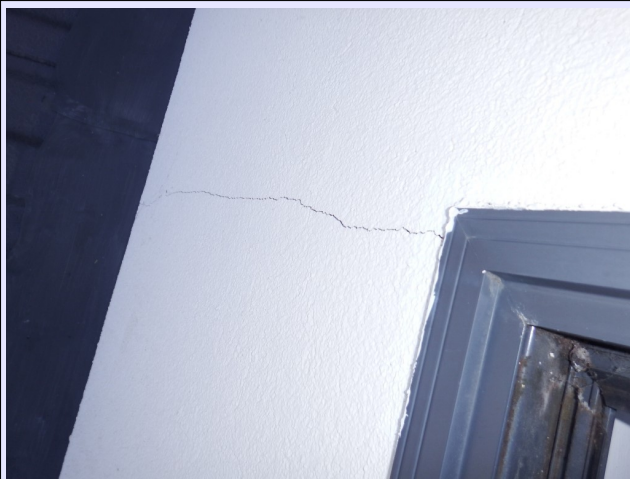
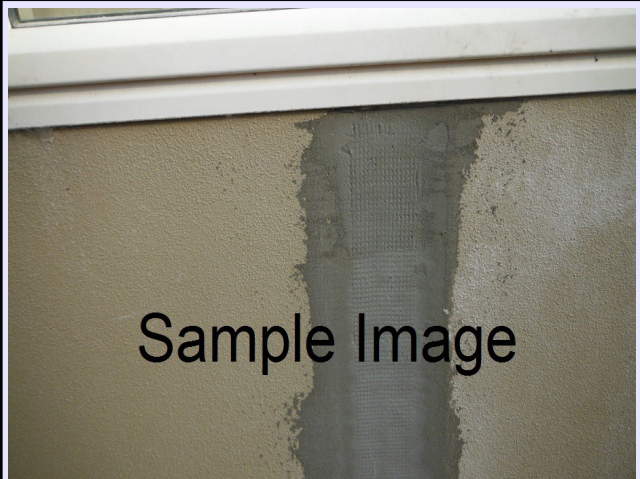
Remedial Work Crack Repairs:

There were cracks in the cladding which require professional repairs to ensure that the property has a good long-term level of weather-tightness.

Plaster Finish:	Plaster was in an acceptable overall condition but there are some areas which require crack repairs mainly at the sheet joins which require remedial work. See page 6 for details
Paint Finish:	Scheduled exterior house painting and joinery resealing maintenance is now due. See following page for plaster cladding maintenance guidelines.
Mid-Section Banding:	Not applicable.
Control Joints:	Recommend that the control joints are resealed in conjunction with scheduled exterior house painting and joinery resealing maintenance.
Ground to Cladding Clearances	Ground to Cladding Clearances were
Weep Holes:	
Joinery:	Aluminium joinery was in an acceptable condition.
Joinery to Cladding Junction:	Joinery to cladding junctions require resealing
Joinery Head Flashings:	Head flashing detail were acceptable
<p>Summary:</p> <p>Exterior was structurally sound and maintaining an acceptable level of weather-tightness. Scheduled exterior house painting and joinery resealing maintenance is now due</p>

Scope of work involves grinding out the cracks and inserting a fiberglass or similar reinforcing mesh and plastering with a Flexi-plast or similar plaster system.

Recommend that repairs to the hairline cracks are carried out in conjunction with scheduled exterior house painting and maintenance. Recommend that remedial work is carried out by a suitably qualified licensed tradesman.

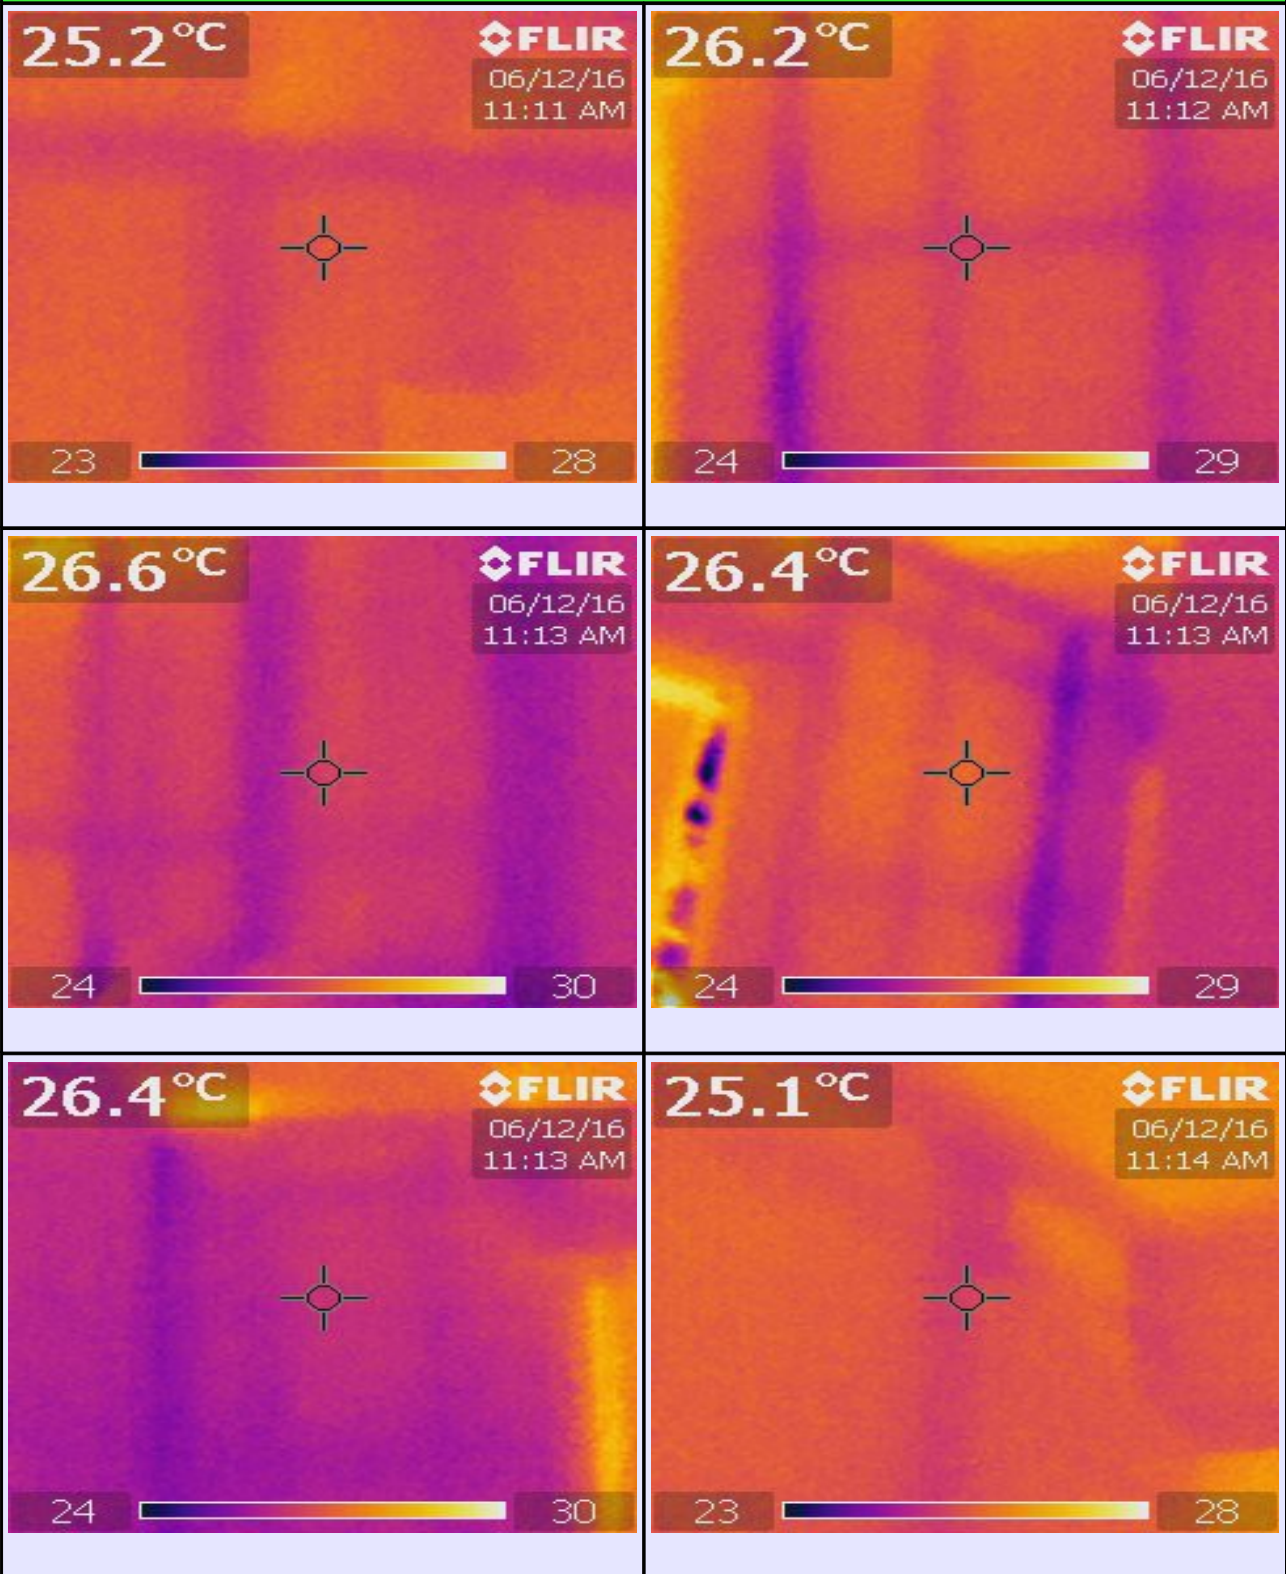
Infrared Thermal Imaging Inspection:

Analysis of the Infrared images showed no thermal anomalies which require further investigation.
