Inspection Details:	Comprehensive Home Owners Inspection Plaster Cladding Weather-tightness Assessment Non-invasive Moisture Testing Infrared Thermal Imaging
Reference:	Sample Report Low Risk Monolithic Plaster Cladding
Inspection Address:	Undisclosed Sample Report Auckland
Date:	Tuesday, December 6, 2016
Client:	Undisclosed
Client Phone Number:	Undisclosed
Time of Inspection:	Undisclosed
Weather:	12:00pm
House Status:	Occupied
Report is prepared for the client only and not transferable	
SPPI PO Box 80-274 Green Bay Auckland 0643	Inspector: Mark Drew NZS 4306 Compliant Building Inspectors Member of Master Builders Association ISO Qualified Thermographer

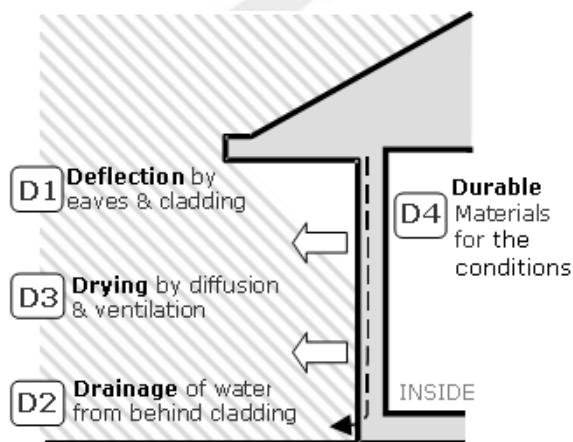
Remedial Work Crack Repairs:

There were cracks in the cladding which require professional repairs to ensure that the property has a good long-term level of weather-tightness.

Internal Inspection of the adjacent areas using moisture testing, visual and thermal imaging recorded no obvious signs of moisture ingress or high moisture readings.

Scope of work involves grinding out the cracks and inserting a fiberglass or similar reinforcing mesh and plastering with a Flexi-plast or similar plaster system.

Recommend that repairs to the hairline cracks are carried out in conjunction with scheduled exterior house painting and maintenance. Recommend that remedial work is carried out by a suitably qualified licensed tradesman.
